RESOLUTION NO. 91-94

AMENDING TRAFFIC RESOLUTION NO. 87-163 TO APPROVE THE SPEED

ZONE SURVEY FROM THE WEST CITY LIMITS TO HAM LANE,

AND APPROVING THE INSTALLATION OF AN OVERHEAD FLASHING BEACON

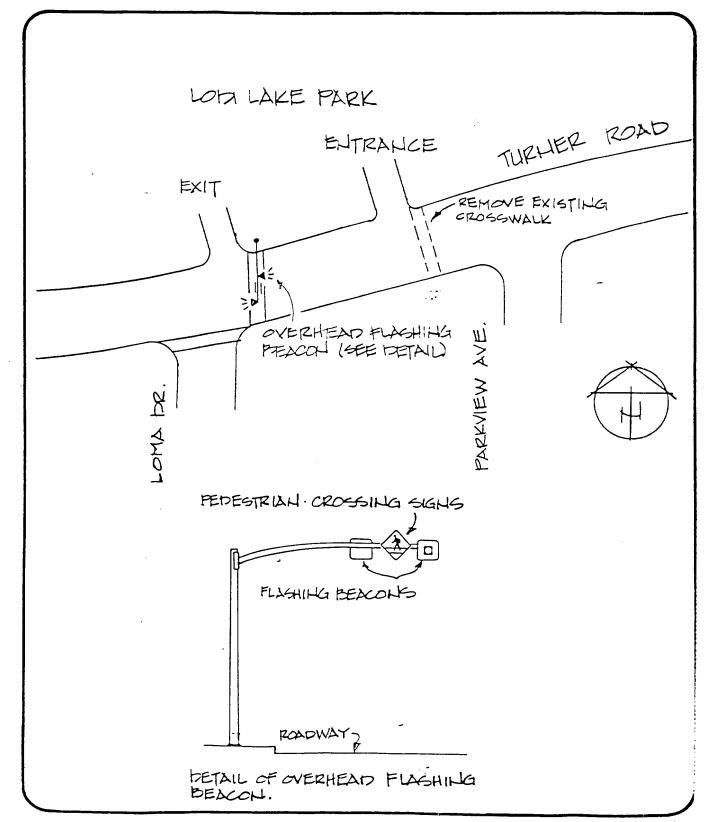
TUEHER ROAD @ LODI LAKE PARK FLAGHING BEACON PLAN

RESOLVED, that the Lodi City Council hereby approves the installation of an overhead flashing beacon at the crosswalk in front of Lodi Lake Park, as shown on Exhibit B attached hereto; and
